Manhole Inspection Summary

Manhole # S21E1_012MH

Insp Date: **5/22/08 10:09 AM**

Location Address: **2643 paca-ridgely alley**

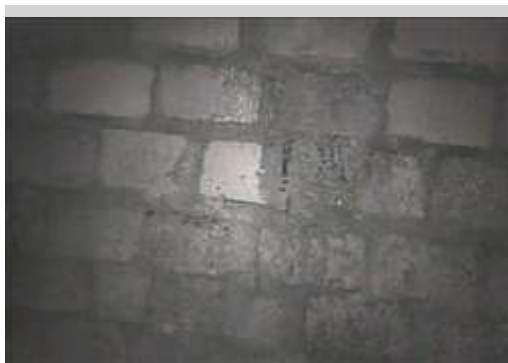
Defect 6

Infiltration: ☐ None ☐ Joint ☐ Cracks ☐ Mortar ☐ Roots ☒ **Wall**

infiltration @ barrel wall

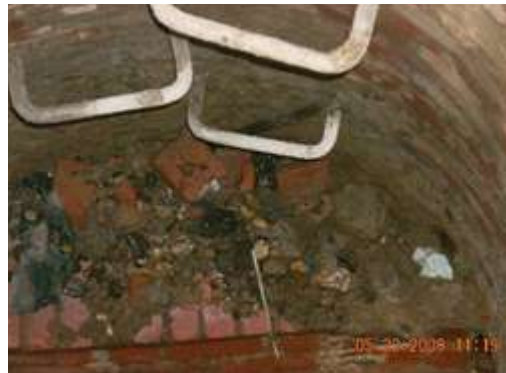
Defect 5

Condition: ☐ Sound ☐ Cracked ☐ Root Intrusion ☐ Deteriorated ☐ Leaks ☒ **Debris**

debris on bench

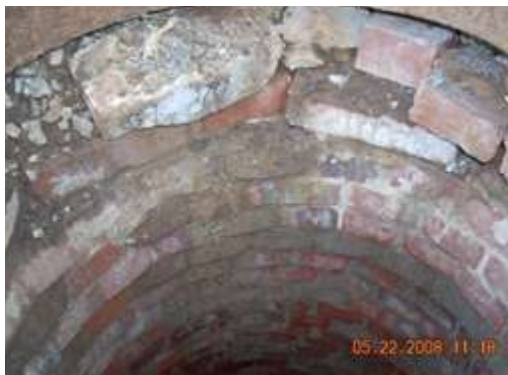
Defect 4

Infiltration: ☐ None ☒ **Joint** ☐ Cracks ☐ Mortar ☐ Roots ☐ Wall

infiltration @ chimney/frame joint

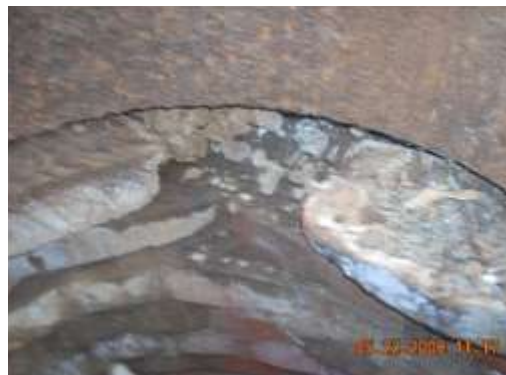
Defect 3

Condition: ☐ Sound ☐ Cracked ☐ Root Intrusion ☒ **Loose Brick** ☒ **Deteriorated**

deteriorated chimney

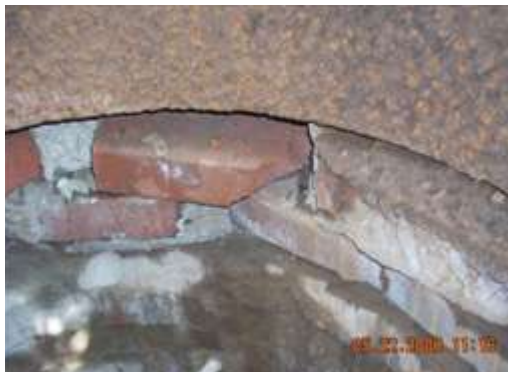
Defect 2

loose chimney bricks

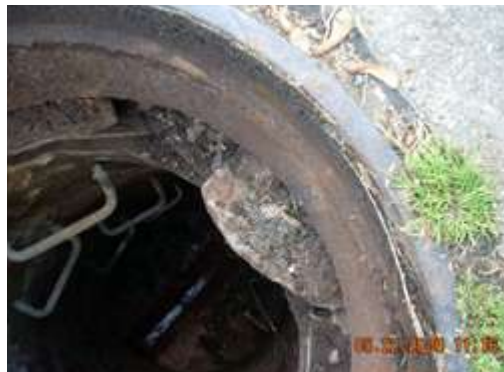
Defect 1

Frame Offset: **3** (in.) Condition: ☒ Sound ☐ Cracked ☐ Leaks

frame offset

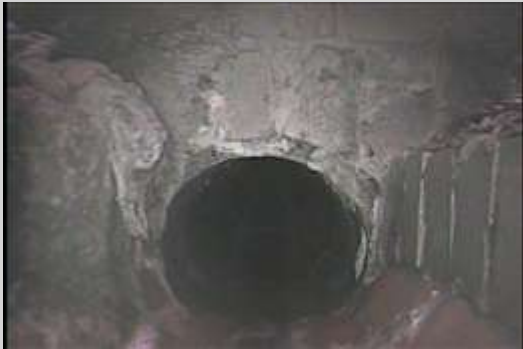
12 O'Clock Outflow

8 in. Circular Gravity Sewer
Pipe Out @ 12 O'Clock

Pipe Height: **8.4** (in.) Rod and Bar (Angled)
Pipe Material: **Clay** ☐ Pipe Lined
Invert Depth: **10.15** (ft.) Flow Characteristics: **Slow**
Deposits: ☒ None ☐ Mud ☐ Sludge ☐ Debris ☐ Grease
Silt Depth: **0** (in.) Deposits Extent:
Infiltration: **None** Pipe Seal Cond: **Sound**

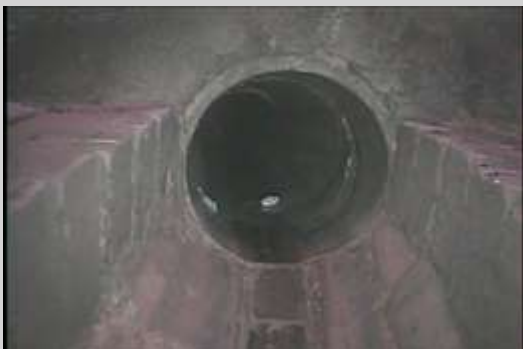
6 O'Clock Inflow

8 in. Circular Gravity Sewer
Pipe In @ 6 O'Clock

Pipe Height: **8.4** (in.) Rod and Bar (Angled)
Pipe Material: **Clay** ☐ Pipe Lined
Invert Depth: **9.70** (ft.) Flow Characteristics: **Slow**
Deposits: ☒ None ☐ Mud ☐ Sludge ☐ Debris ☐ Grease
Silt Depth: **0** (in.) Deposits Extent:
Infiltration: **None** Pipe Seal Cond: **Sound**
